PE-Xc pipes and MT multilayer pipes with insulation

Thermal insulation and condensation protection

Applications: Tap water installations, radiator connections

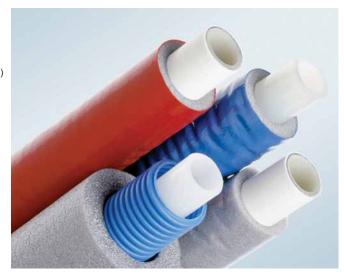
The additional outer PE layer protects effectively against exterior moisture and mechanical damage.
